CAESAR CREEK LAKE
LITTLE MIAMI RIVER BASIN
OHIO

EMBANKMENT CRITERIA AND
PERFORMANCE REPORT

PREPARED BY
U.S. ARMY ENGINEER DISTRICT, LOUISVILLE
CORPS OF ENGINEERS

SEPTEMBER 1982

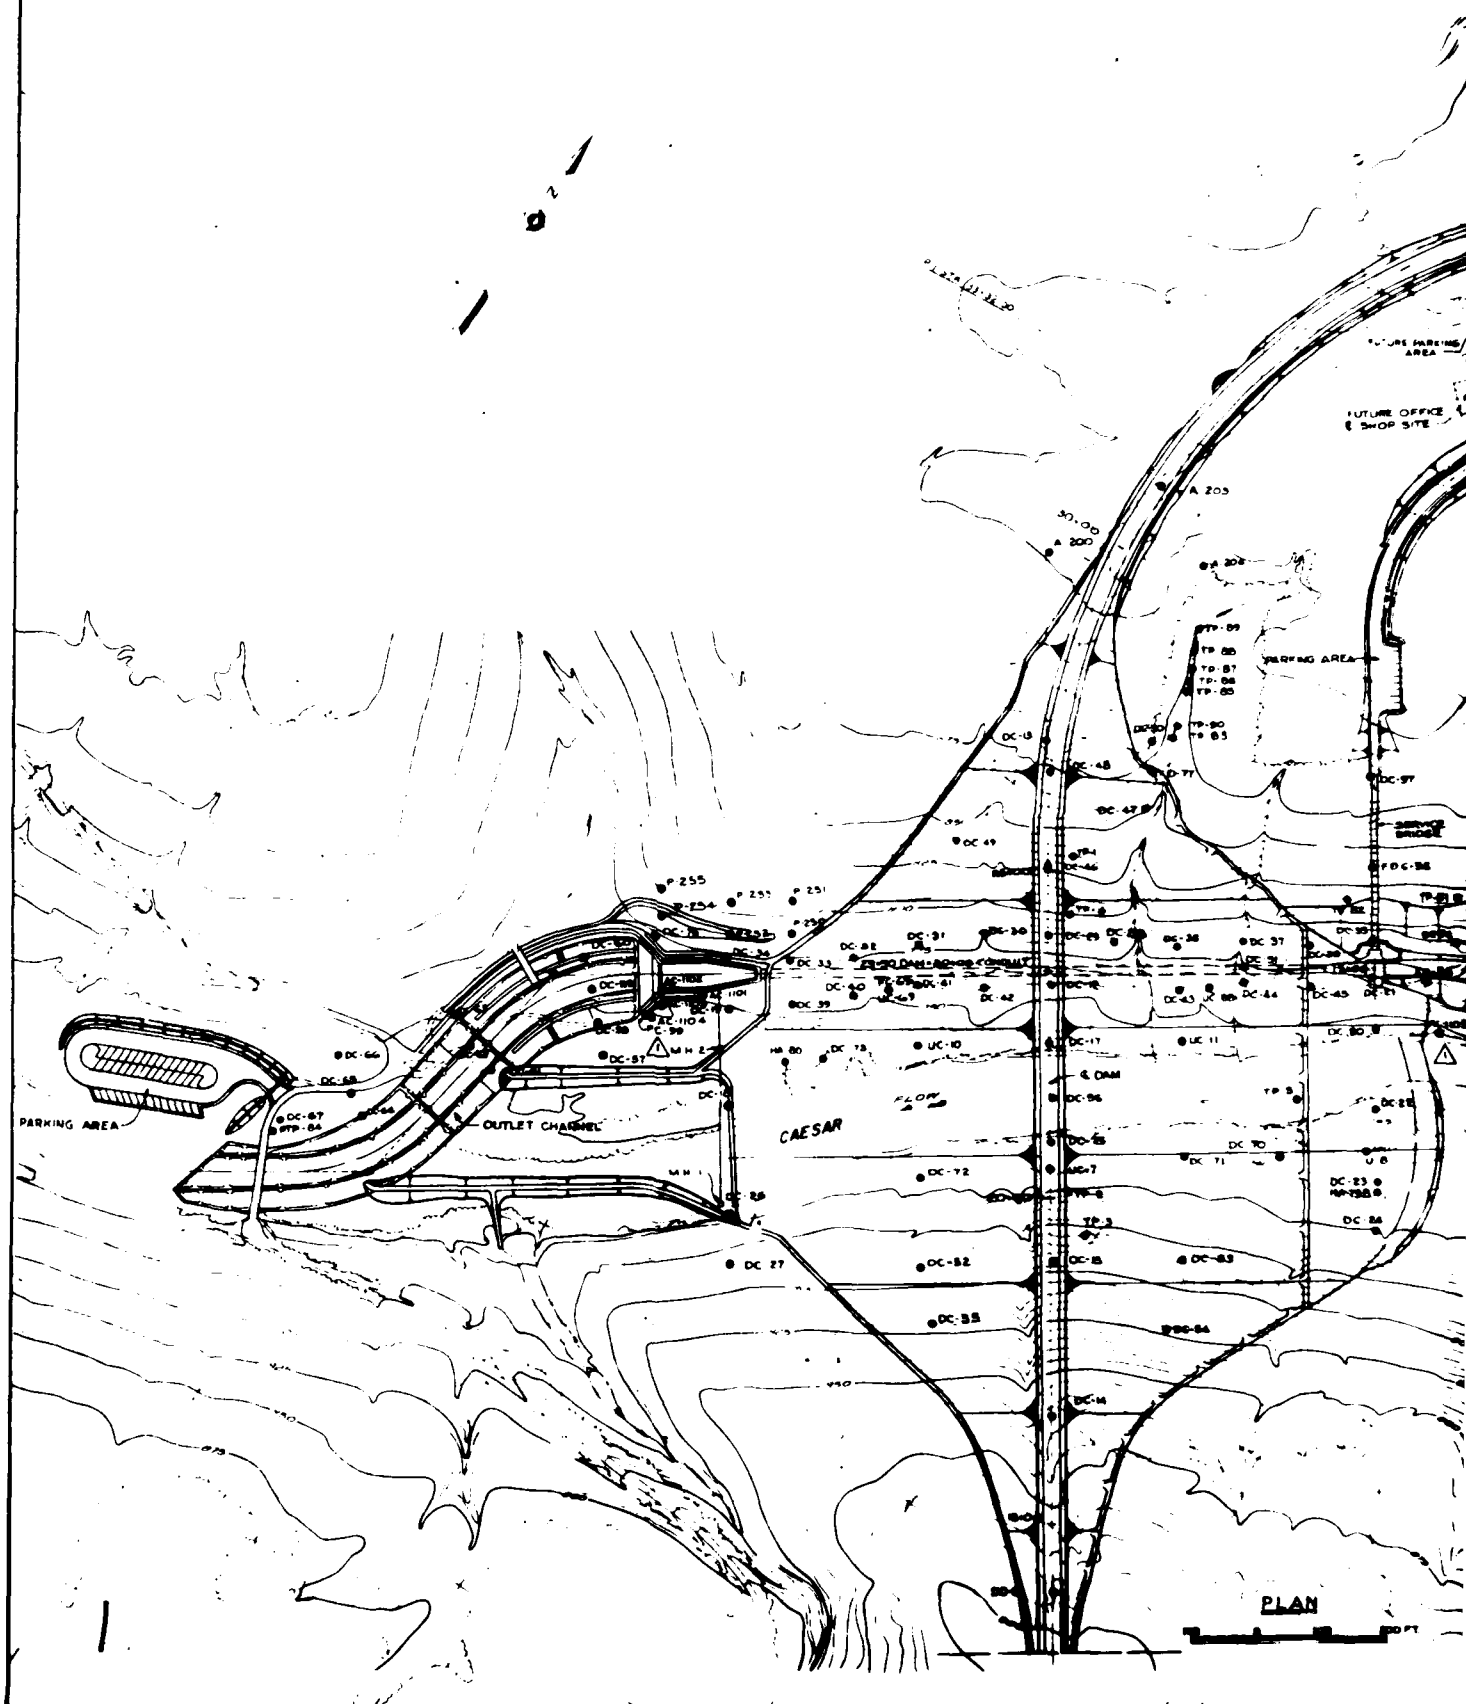
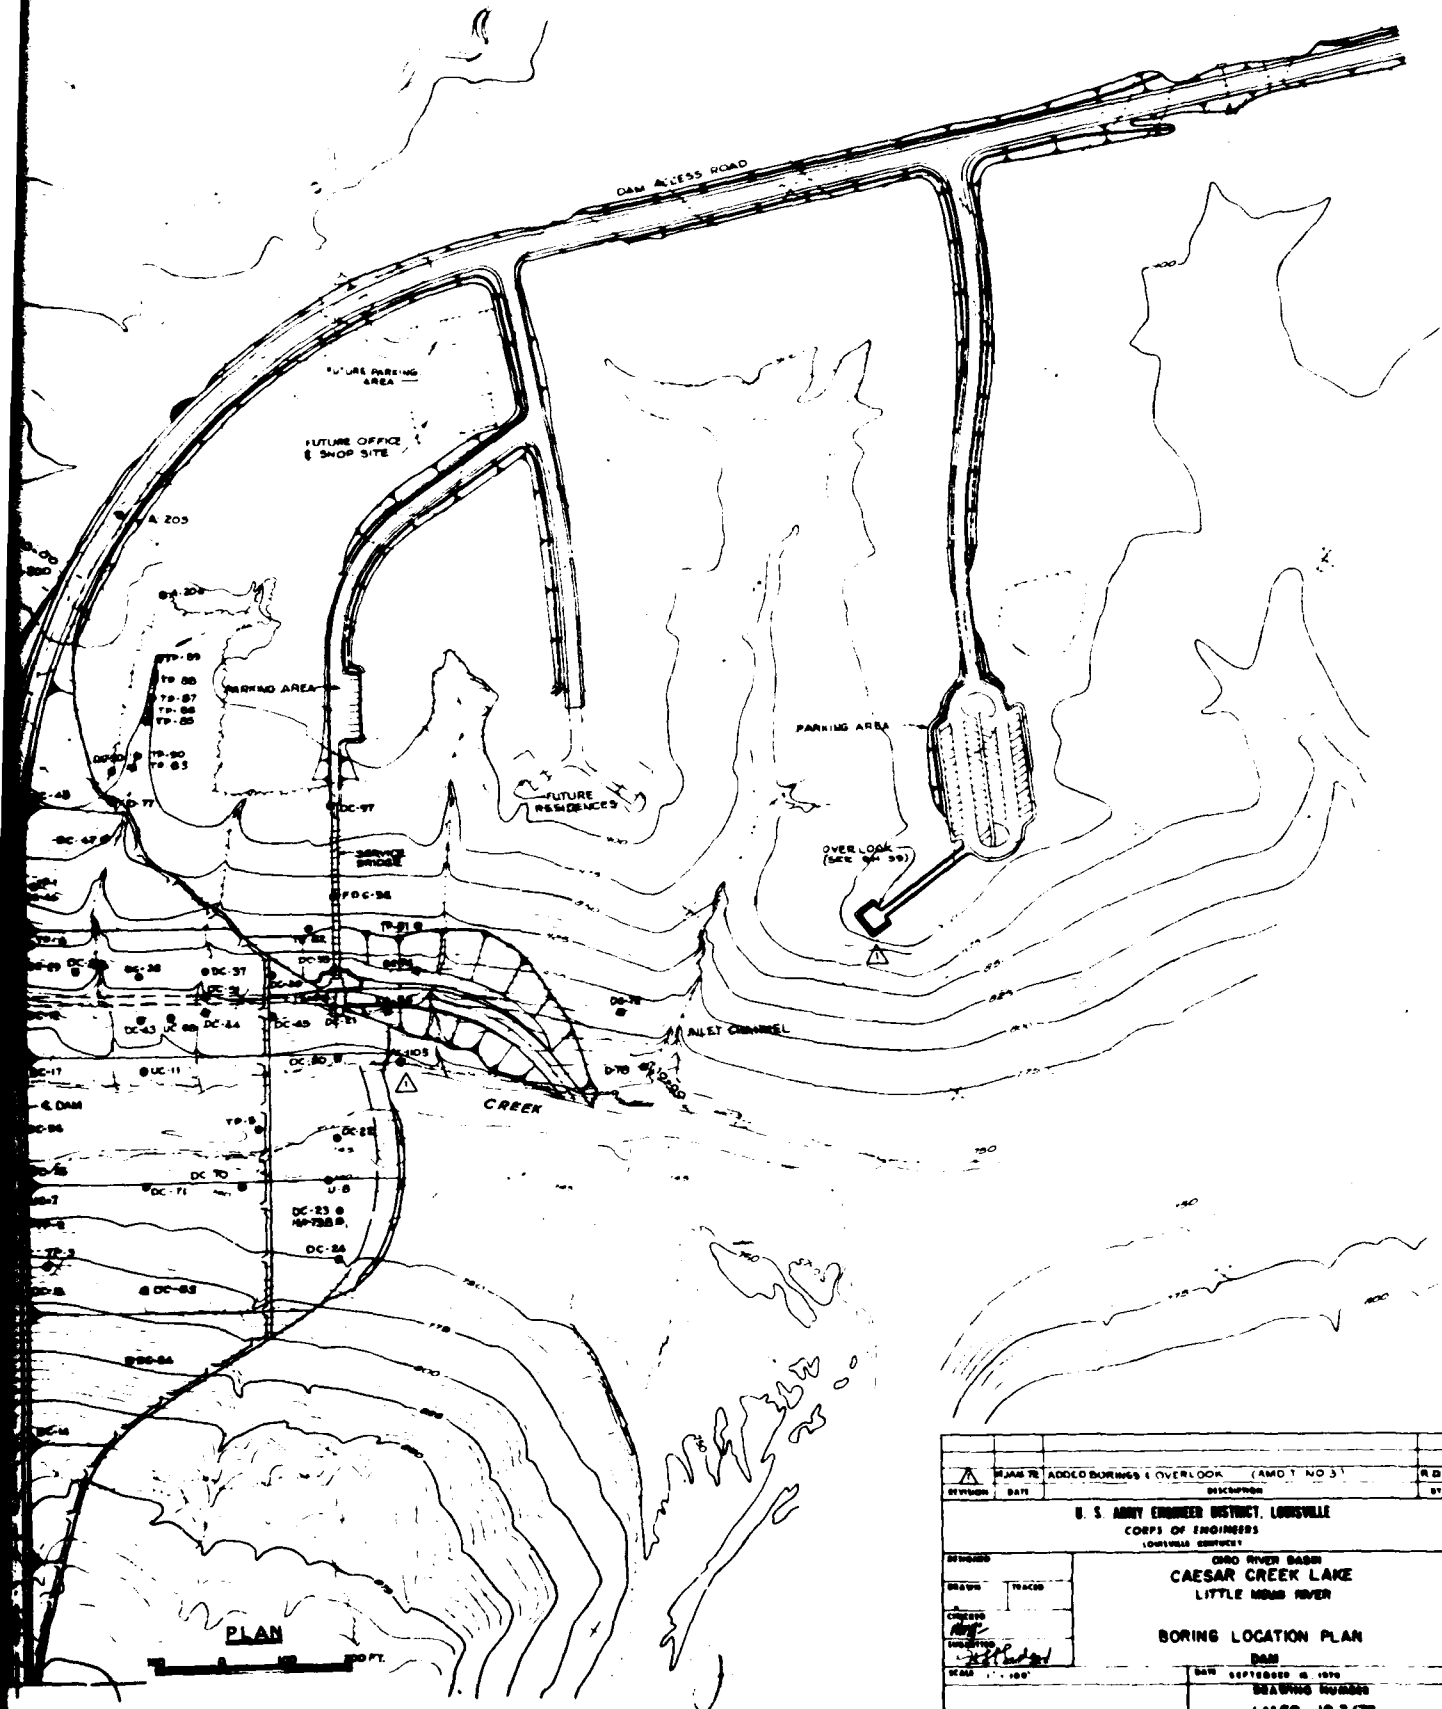
<p>PLAN 30 ADDED BORINGS & OVERLOOK (AMDT NO 3)</p>		<p>DATE</p>	<p>DESCRIPTION</p>	<p>BY</p>
<p>U. S. ARMY ENGINEER DISTRICT, LOUISVILLE CORPS OF ENGINEERS LOUISVILLE DISTRICT</p>				
<p>DESIGNED</p>		<p>DRD RIVER BASIN CAESAR CREEK LAKE LITTLE MISSISSIPPI RIVER</p>		
<p>DRAWN</p>		<p>BORING LOCATION PLAN</p>		
<p>SCALE 1" = 100'</p>		<p>DATE SEPTEMBER 18, 1976 DRAWING NUMBER LM 52-12.3/76</p>

b. Damsite. The topography along Caesar Creek in the damsite area is characterized by a broad, flat upland which has a steep-sided rock cut gorge running throughout. Rock outcrops in the tributary streams immediately upstream and downstream from the dam centerline. The drainage pattern is dendritic. Tributary streams are fed from springs high on the drainage divide and flow along gentle gradients in the glacial till and finally along bedrock near the mouth. Residual lean to fat clay is found on both abutment side slopes and in the spillway area. On the left abutment it is 2 to 5 feet thick whereas on the right abutment side slopes it is as thick as 10 feet. The clay is moderately firm with limestone fragments scattered throughout. In the spillway area the clay is 2 to 12 feet thick. Along the toe of the right abutment is 16 to 26 feet of colluvium. The colluvium varies from a fat clay to a gravelly clay. Colluvium is also found on top of the drainage divide in both abutments. Wisconsinian till is found on the right bank and Illinoian till is found on the left. On the right abutment the till thickness varies from 10 to 30 feet. The top 10 to 15 feet is a brown leached clay till which overlies 10 feet of gray clay till. The lower 3 to 8 feet is a gray brown clay till, Illinoian in age. On the left abutment the maximum thickness of overburden is found, just at the top of the hill where a topographic high is evident. The till has a maximum thickness of 28 feet and thins out toward the spillway where overburden is 2 to 7 feet thick and is primarily a residual lean clay with rock fragments. Alluvial sandy clay and gravel is found in the narrow valley bottom. Immediately overlying bedrock is a sandy gravel with some silt, clay and organic clay. The gravel has a maximum thickness of 20 feet at the downstream left bank toe. Overlying the gravel is some 10 to 15 feet of sandy silty clay which is soft to moderate soft. The geologic profiles and sections for the dam are shown on plates 4 through 10. For reference, a boring location plan is presented on plate 3.

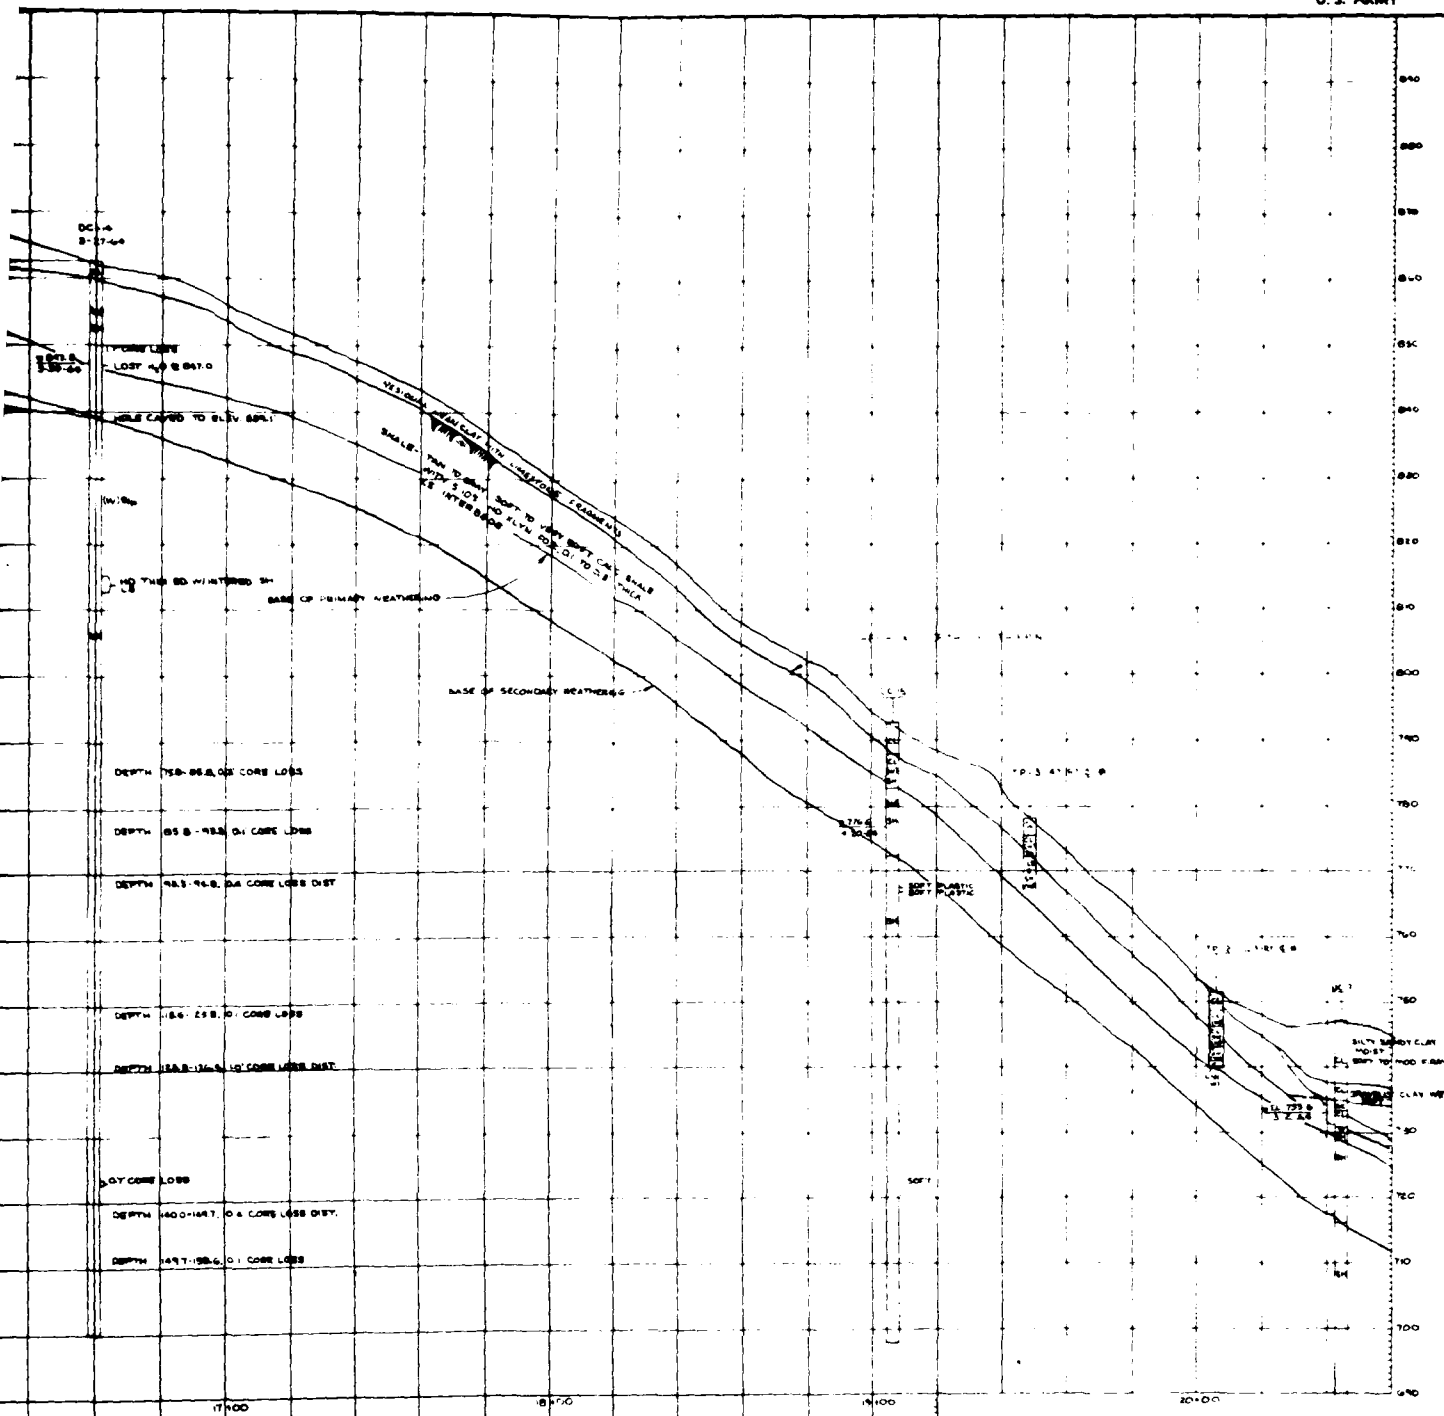
PROFILE EXTENDED		SHEET	
SECTION		DATE		DESCRIPTION	
U. S. ARMY ENGINEER DISTRICT, LOUISVILLE CORPS OF ENGINEERS LOUISVILLE, KENTUCKY					
DESIGNED:		OHIO RIVER BASIN CAESAR CREEK RESERVOIR LITTLE MIAMI RIVER GEOLOGIC PROFILE DAM			
DRAWN: <i>WRC</i>		SHEET 1			
CHECKED: <i>WRC</i>		APPROVED: <i>WRC</i>			
SPECIAL INSTRUCTIONS:		SCALE:			
R. H. Meyer		DRAWING NUMBER:

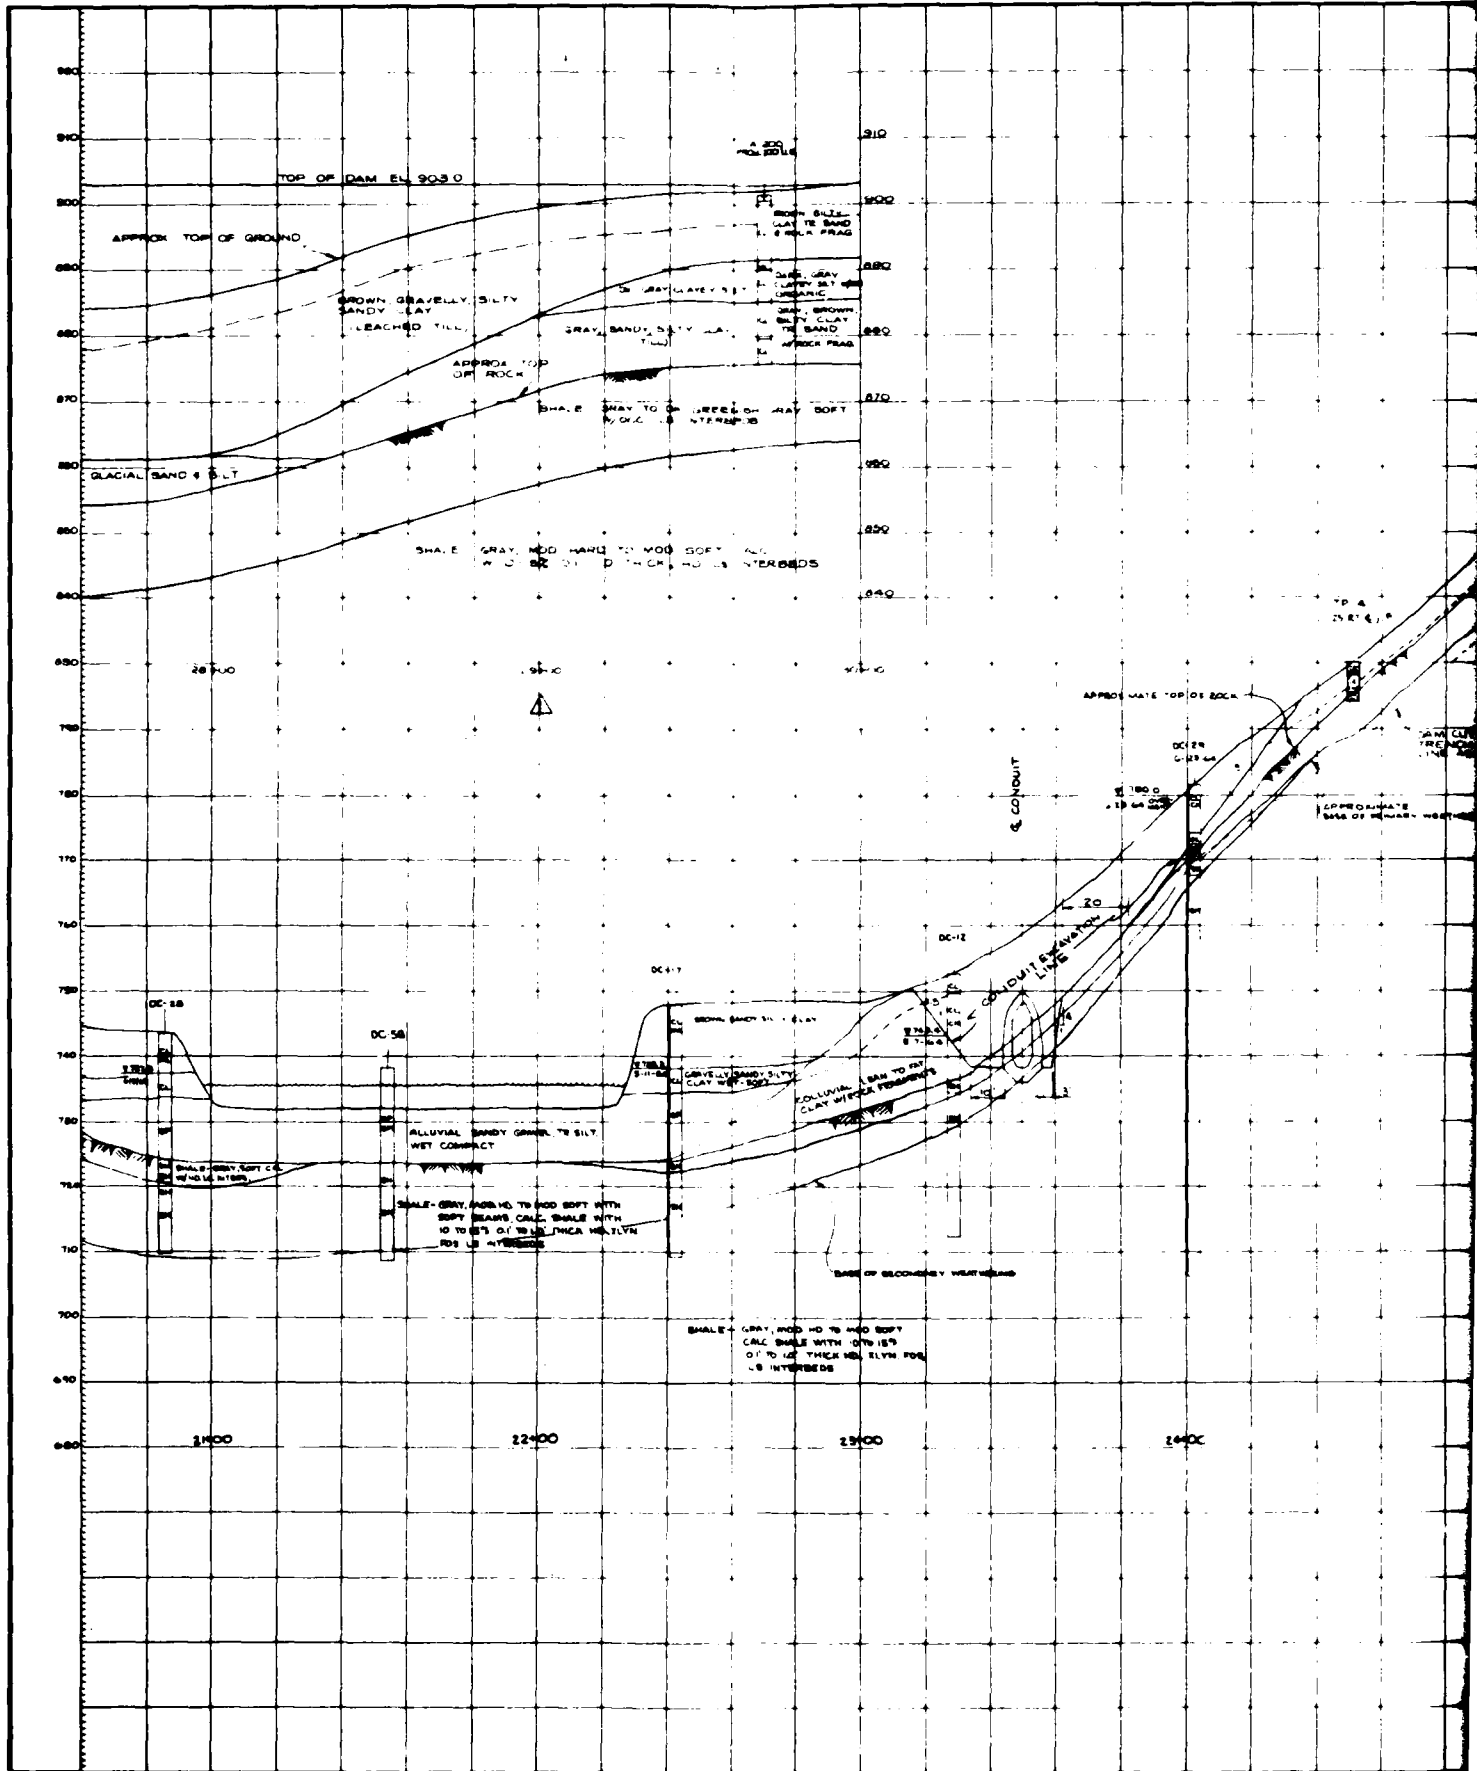
DATE <u>JUNE 1</u> PROFILE EXTENDED		DESCRIPTION		SHEET <u>1</u> OF <u>1</u>	
DRAWING DATE		U S ARMY ENGINEER DISTRICT, LOUISVILLE CORPS OF ENGINEERS LOUISVILLE OFFICE			
DESIGNED DRAWN CHECKED SURVEYED APPROVED FOR CHIEF OF DISTRICT		OHIO RIVER BASIN CAESAR CREEK RESERVOIR LITTLE MIAMI RIVER GEOLOGIC PROFILE DAM SHEET 2		SCALE DRAWING NUMBER	
APPROVED R. M. Hays		APPROVED W. R. [Signature] CHIEF OF DISTRICT		DRAWING NUMBER

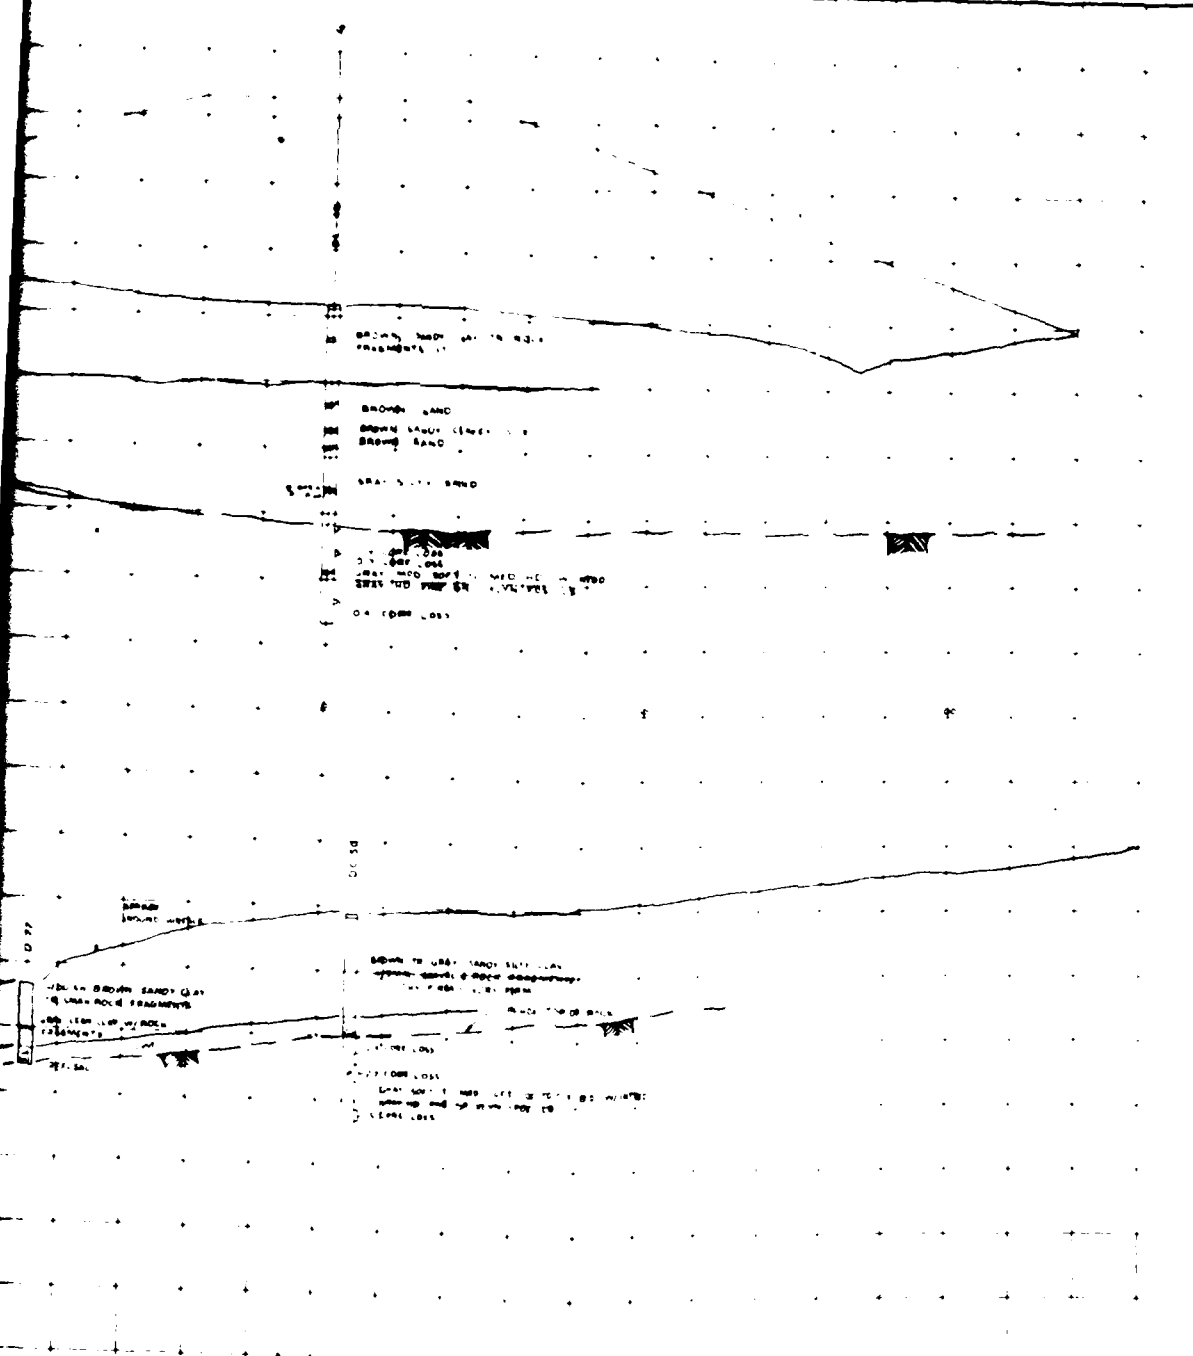
DIVISION		DATE		DESCRIPTION	
U. S. ARMY ENGINEER DISTRICT, LOUISVILLE					
CORPS OF ENGINEERS					
LOUISVILLE DISTRICT					
DESIGNED		OLD RIVER BRIDGE			
DRAWN		CAESAR CREEK RESERVOIR			
CHECKED		LITTLE MAINE RIVER			
SUBMITTED		RIGHT ABUTMENT			
SCALE		GEOLOGIC PROFILE & SECTION			
		DRAWING NUMBER

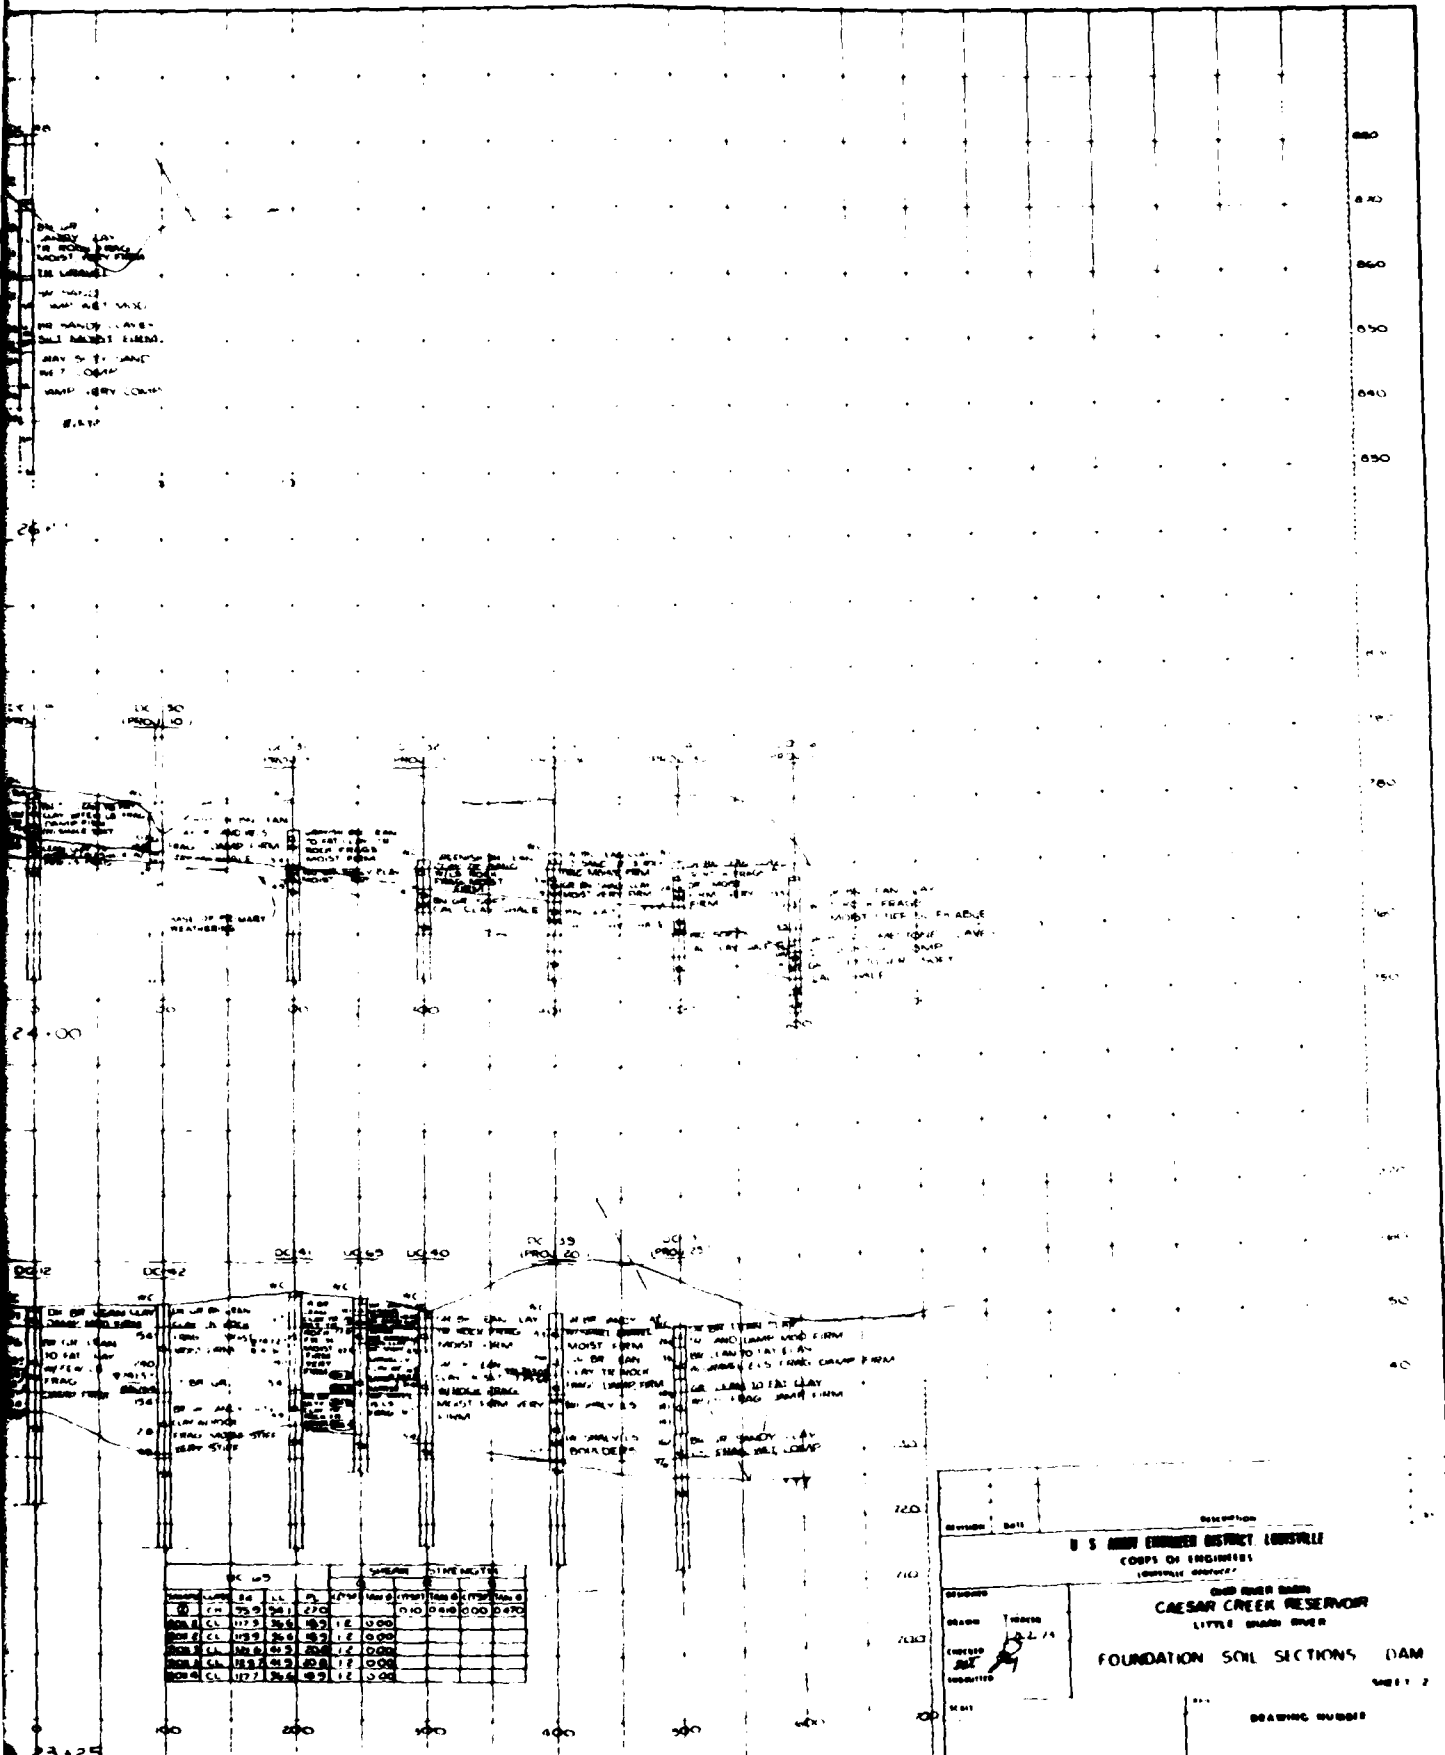
PLATE 10

CAESAR CREEK RESERVOIR
FOUNDATION SOIL SECTIONS DAM

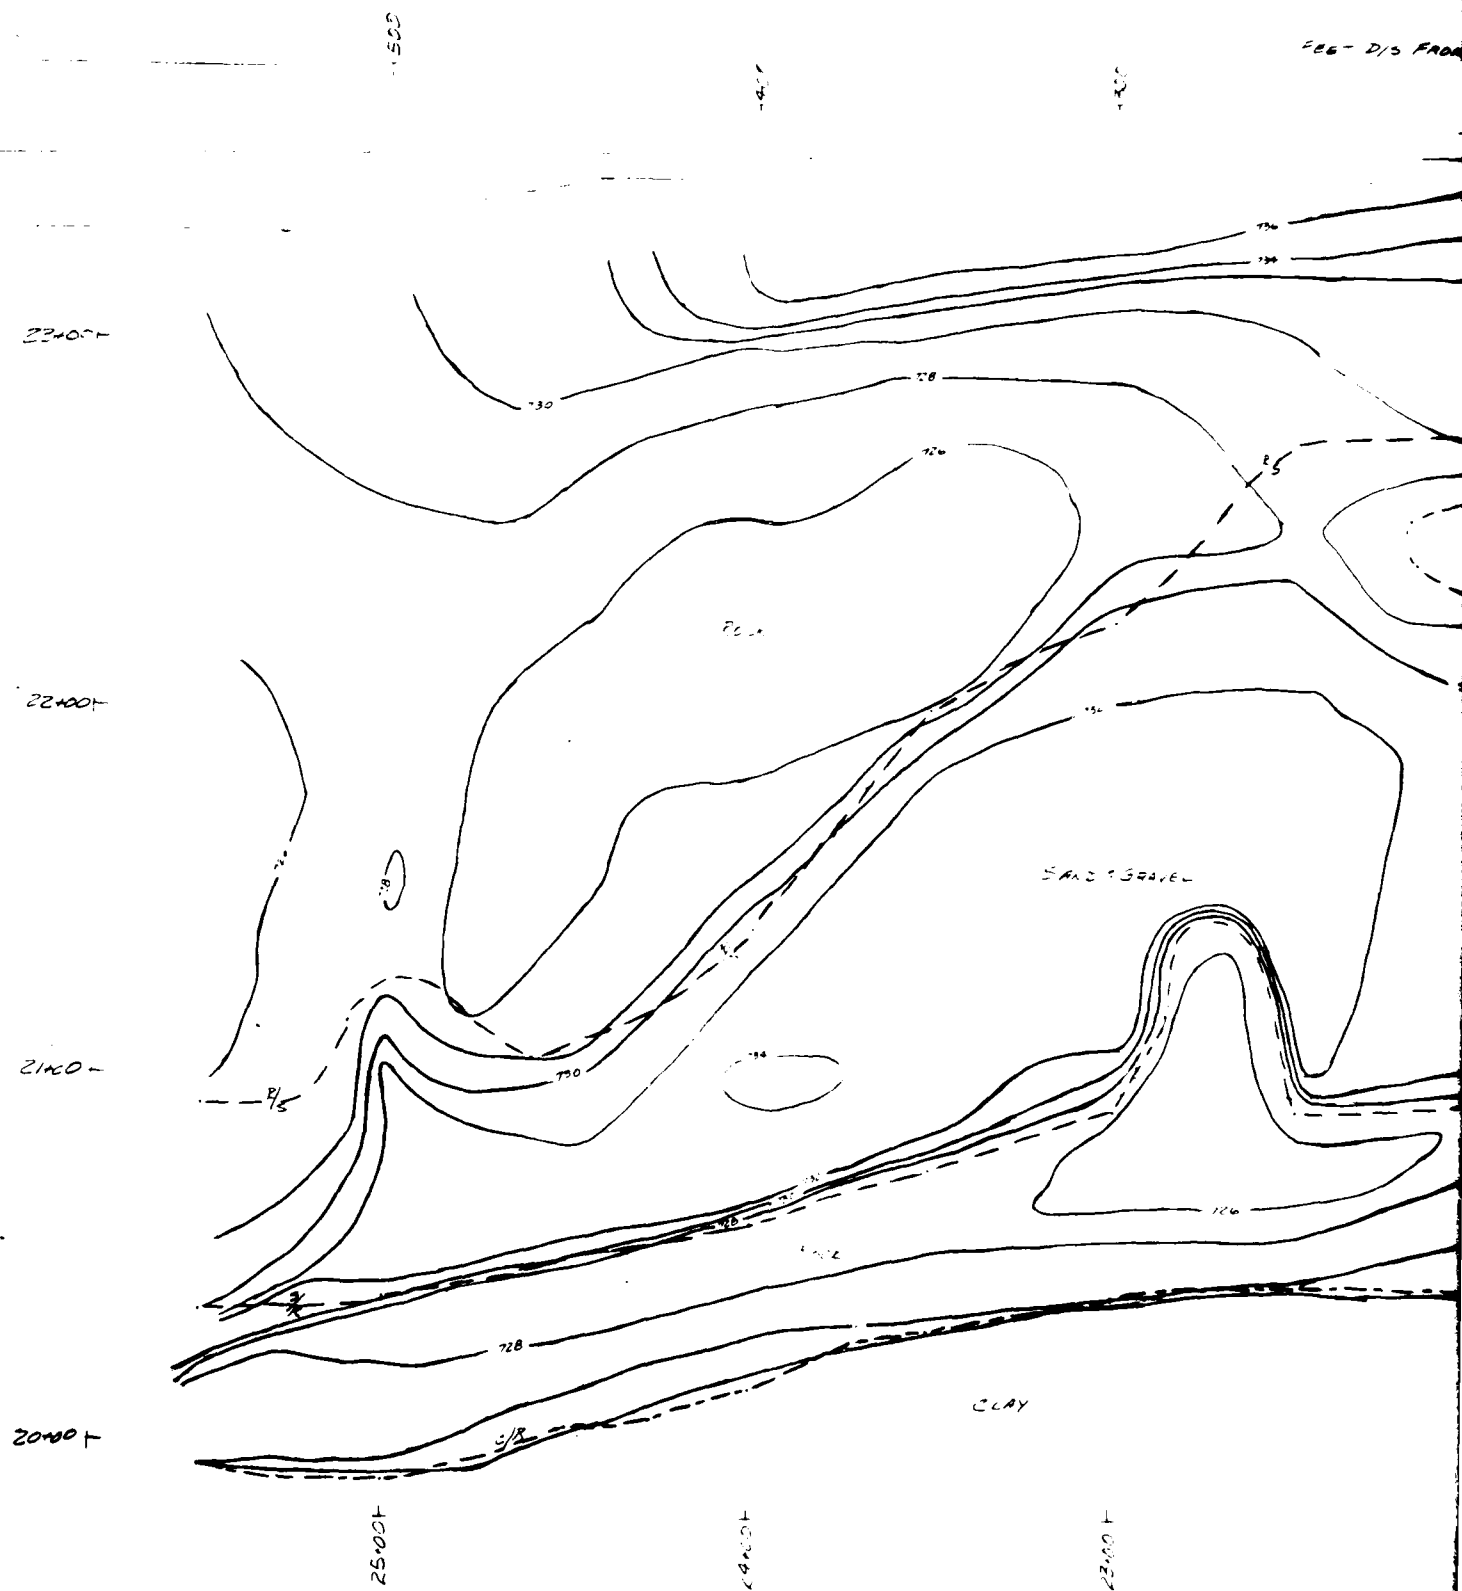
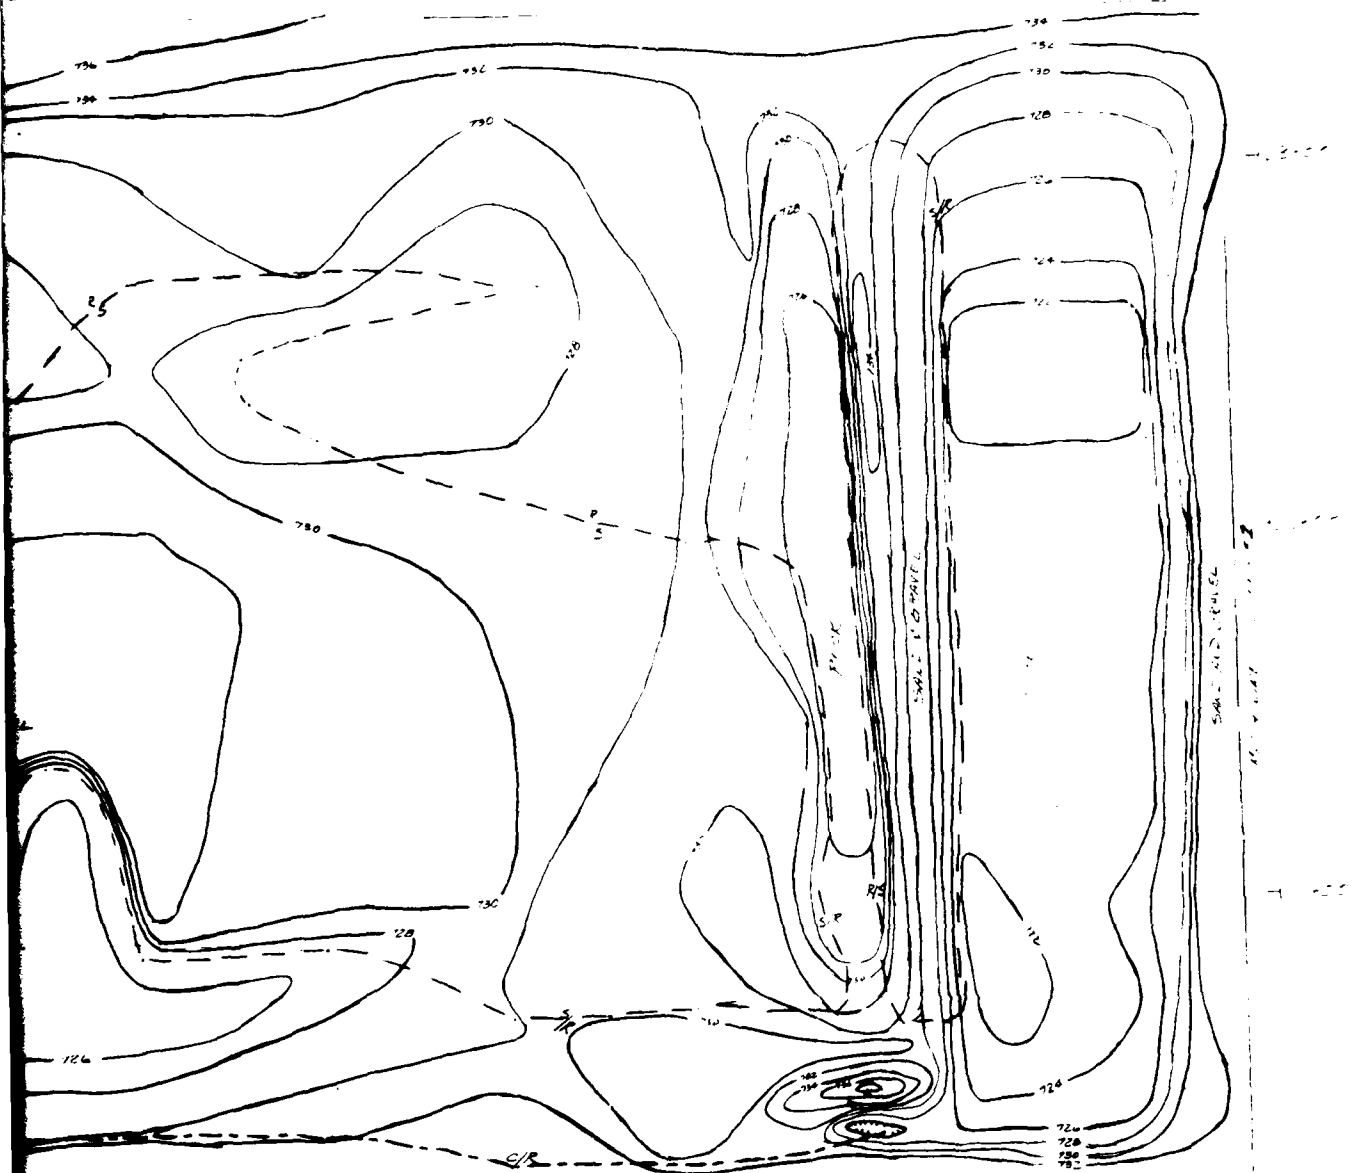
PLATE 14

CASSADUN RIVER LAKE
VALLEY FORMATION
LEGEND
P/S ROCK-SAND INTERFACE
C/P CLAY-ROCK CONTACT
0 10 20 30 40 50 60 70 80 90 100
SHEET 2
PLATE 13

3. Foundation and Abutment Treatment. The general abutment stripping varied from 1 to 3 feet in depth to residual soil. Stripping in the valley to much greater depths was necessary to remove wet and weak materials that contained organic materials in and adjacent to the stream-bed. The valley was excavated to sand and gravel or bedrock. The greatest depths of excavation were along the left side of the valley and at the downstream central portion where brown silty clays and scattered pockets of peat were removed to bedrock at elevation 725. The elevations of the stripped valley foundations are shown on Plates 13 and 14.

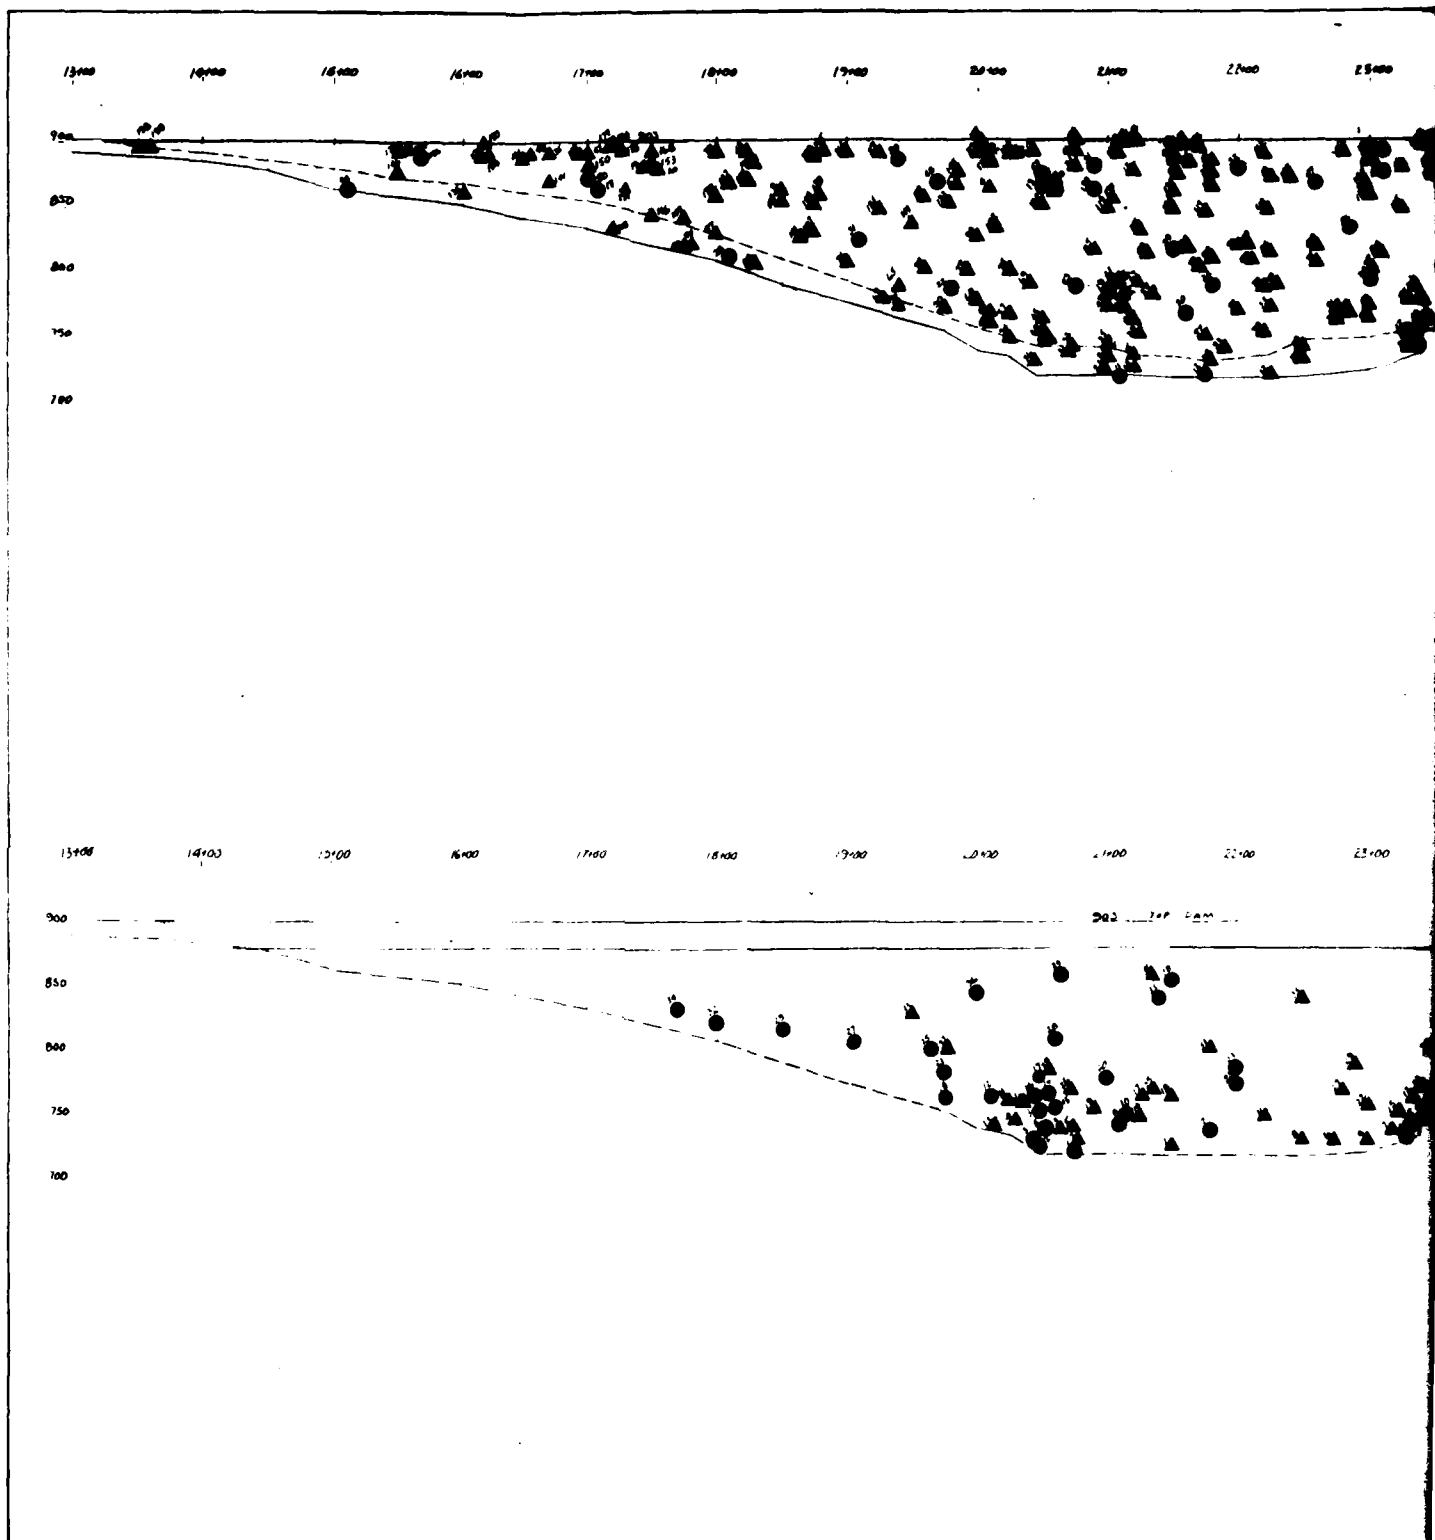
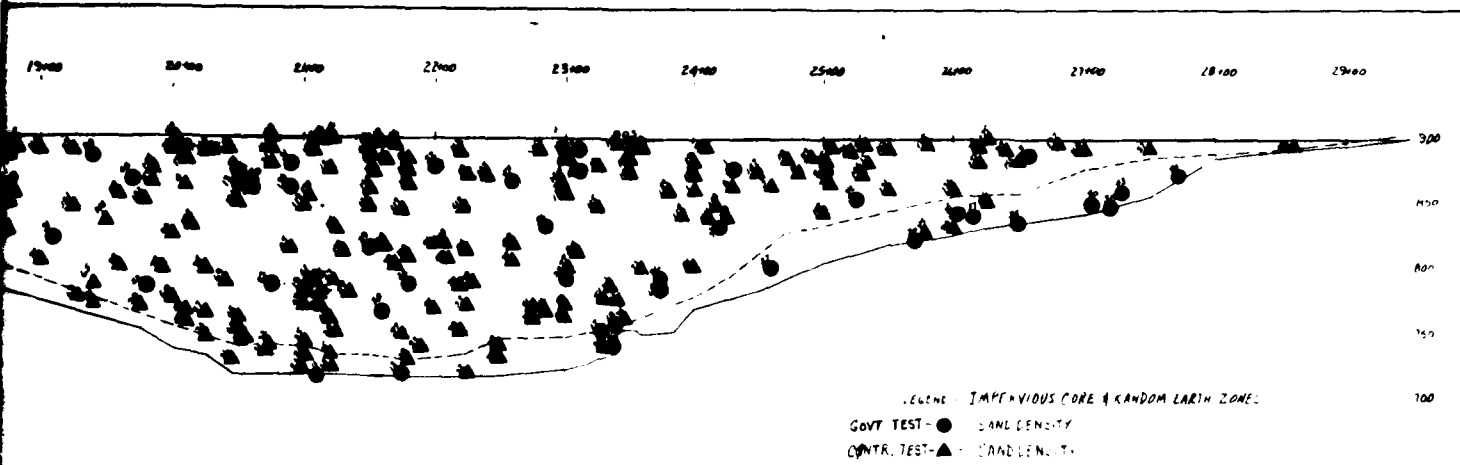
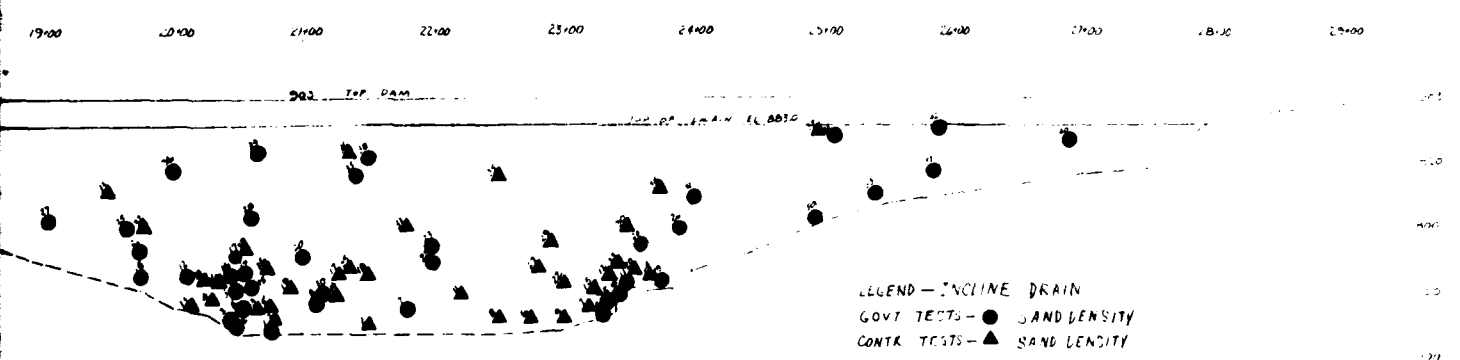
REVISION		DATE	DESCRIPTION	BY
U. S. ARMY ENGINEER DISTRICT, LOUISVILLE CORPS OF ENGINEERS LOUISVILLE DISTRICT				
DESIGNED		CAESAR CREEK LAKE DENSITY TESTS IMPERVIOUS-RANDOM EARTH INCLINED DRAIN		
DRAWN	TRACED			
CHECKED				
SUBMITTED				
SCALE	DATE		DRAWING NUMBER	
			1 2

In the compaction of the impervious and random earth embankment materials, the design requirements for density were considered met if the field density tests indicated densities of the compacted materials were 95 percent or greater of the maximum densities as determined from EM 1110-2-1906 Appendix VI (Standard Compaction Test). A nest of moisture-density curves covering the range of soil used was developed. (See plates 24 through 26.) Soils with 100 percent passing the No. 4 sieve were
